## Management Report

DP Management  
Delta Plaza  
301 North Lincoln, Escanaba, MI

Prepared For  
**DP**  
MANAGEMENT, LLC

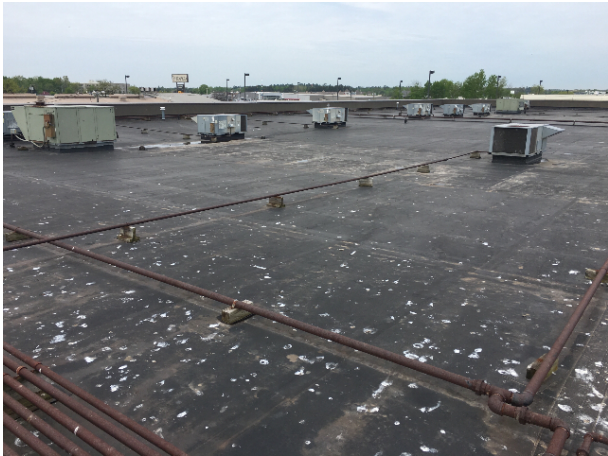
Section 6  
Looking West towards Shopko

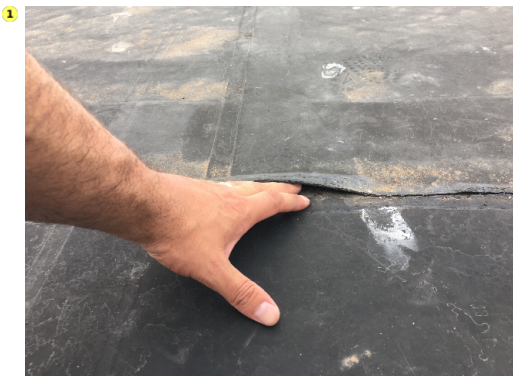
### General - Open Seams (Emergency)

Quantity: 600 LF

Open seams in the waterproofing membrane are typically caused by failing seam adhesives coupled with membrane shrinkage and stress on the seams.

The area surrounding the open seam must be cleaned. A new piece of waterproofing membrane would be installed and sealed per industry standards.

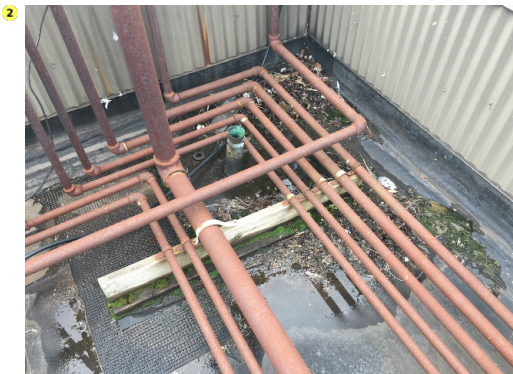
### General - Vegetation (Remedial)

Quantity: 600 SF

Vegetation growth on roof

Remove and dispose of the vegetation.

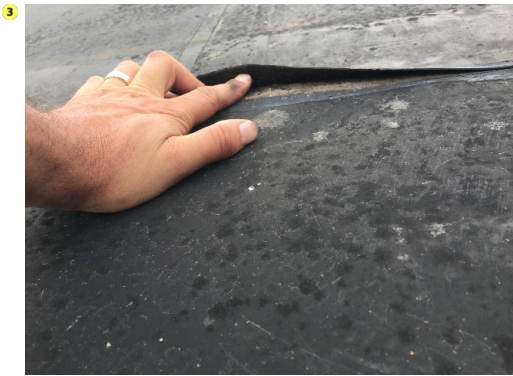
### General - Open Seams (Emergency)

Quantity: 100 LF

Open seams in the waterproofing membrane are typically caused by failing seam adhesives coupled with membrane shrinkage and stress on the seams.

The area surrounding the open seam must be cleaned. A new piece of waterproofing membrane would be installed and sealed per industry standards.

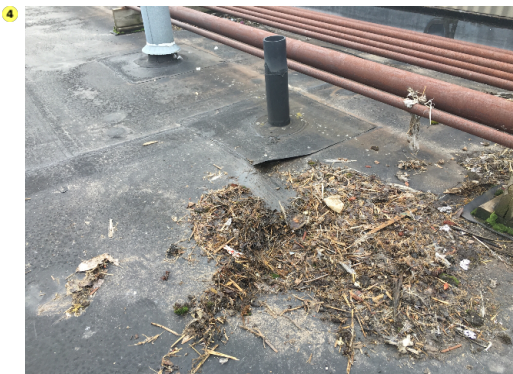
### General - Failing Penetration (Emergency)

Quantity: 1 EA

Due to overall age, weathering and UV the penetration has failed.

The penetration should be repaired/flushed per industry standards to ensure a water tight seal.

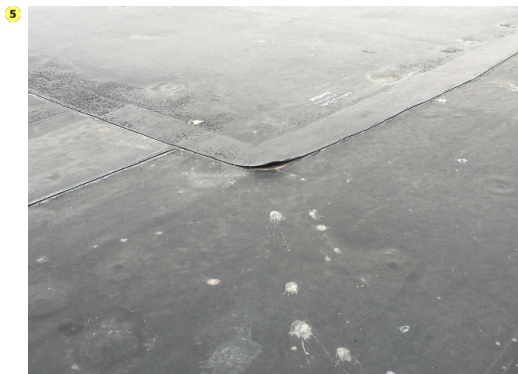
**General - Previous Repair Failure (Emergency)**

Quantity: 4 EA

Existing repair failing due to age or improper repair.

We will remove the existing repair, clean and prime area and install new patch to ensure water tightness.

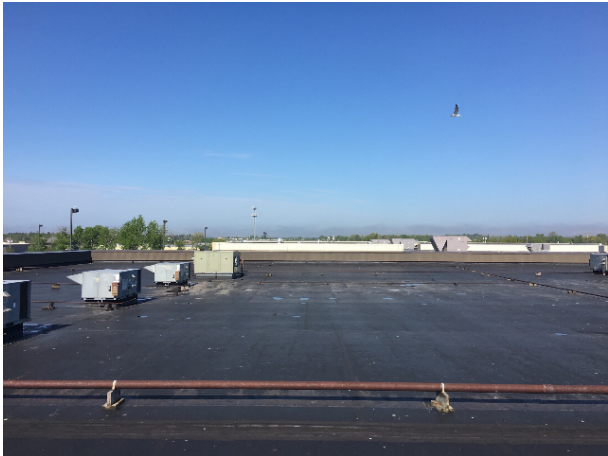
Section 7  
Looking West towards Shopko

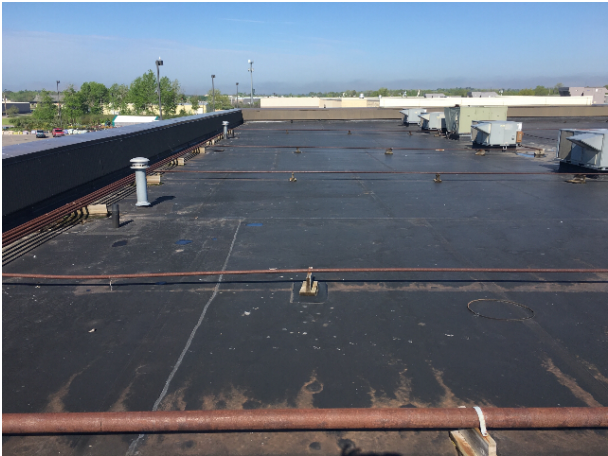
Section 7  
Looking West towards Shopko

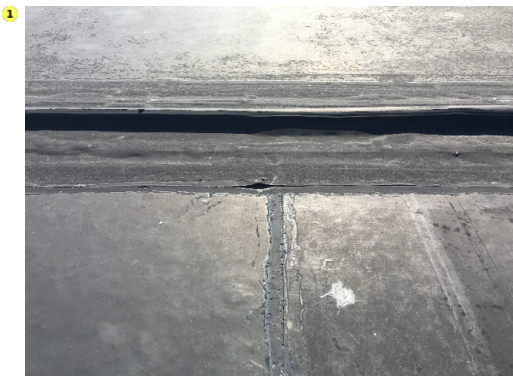
### General - Membrane Fish Mouth (Remedial)

Quantity: 1 EA

Example of fish mouths on membrane laps that is allowing water into the system.

We will cut the fish mouth out, clean and prime the area and install new patch over effected area to ensure water tightness.

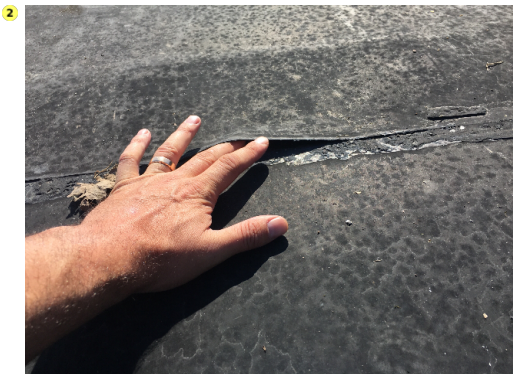
### General - Membrane Laps (Emergency)

Quantity: 900 LF

open membrane laps are allowing water into the system.

Seal open laps by cleaning and priming the area, re-heating the lap or installing a new patch over effected area to ensure water tightness.

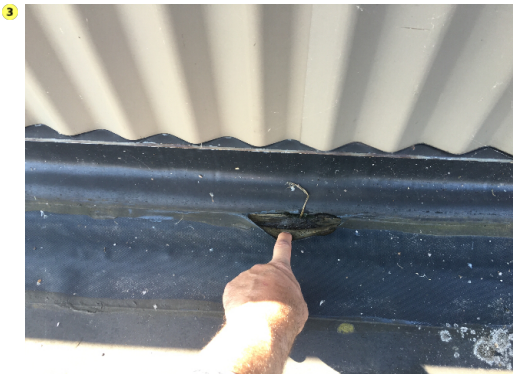
### General - Base Flashing Lap (Emergency)

Quantity: 50 LF

Open lap in base flashing. Wood blocking is exposed and currently wet behind membrane.

We will clean and prime lap then install new patch to ensure water tightness.

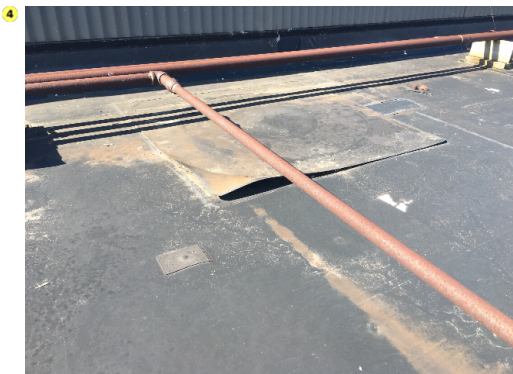
### General - Previous Repair Failure (Emergency)

Quantity: 5 EA

Existing repair failing due to age.

We will remove the existing repair, clean and prime area and install new patch to ensure water tightness.

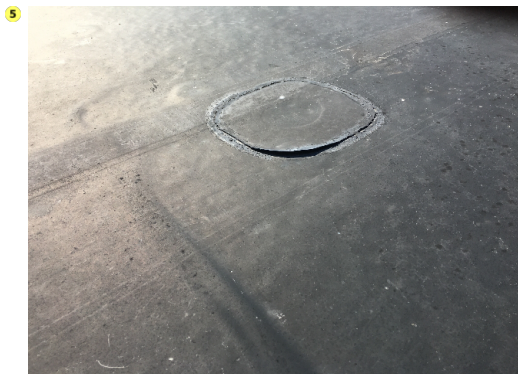
**General - Previous Repair Failure (Emergency)**

Quantity: 1 EA

Existing repair failing due to age.

We will remove the existing repair, clean and prime area and install new patch to ensure water tightness.

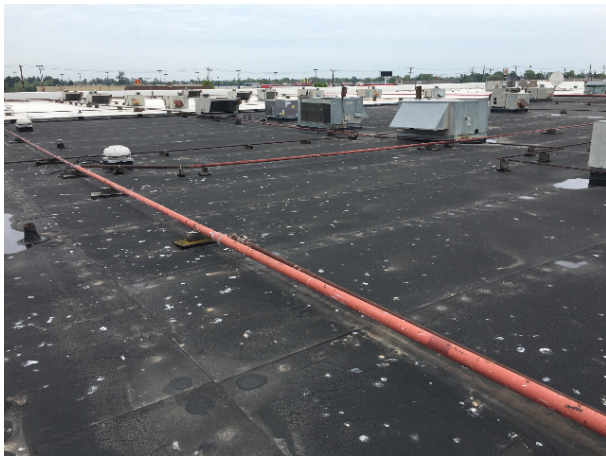
Section 8  
Looking East

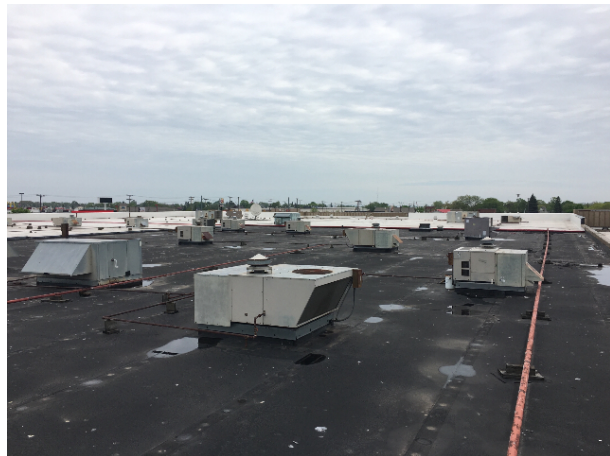
Section 8  
Looking East

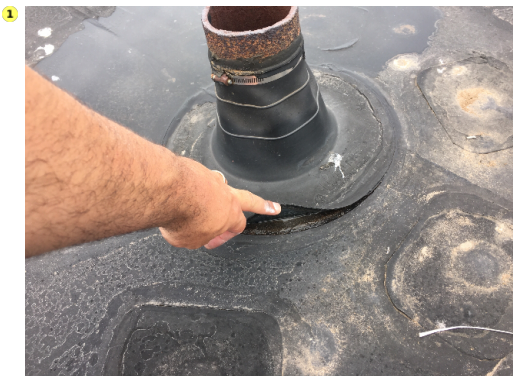
### General - Failing Penetration (Emergency)

Quantity: 4 EA

Due to overall age, weathering and UV the penetration has failed.

The penetration should be repaired/flashed per industry standards to ensure a water tight seal.

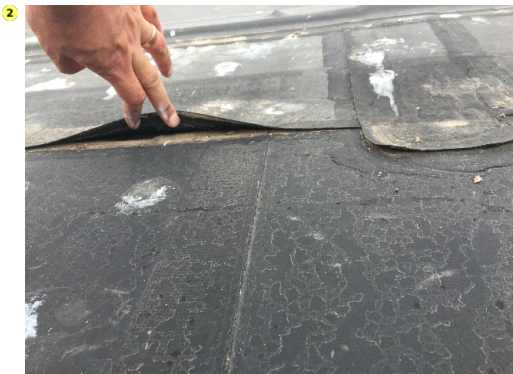
### General - Membrane Laps (Emergency)

Quantity: 800 LF

open membrane laps are allowing water into the system.

Seal open laps by cleaning and priming the area, re-heating the lap or installing a new patch over effected area to ensure water tightness.

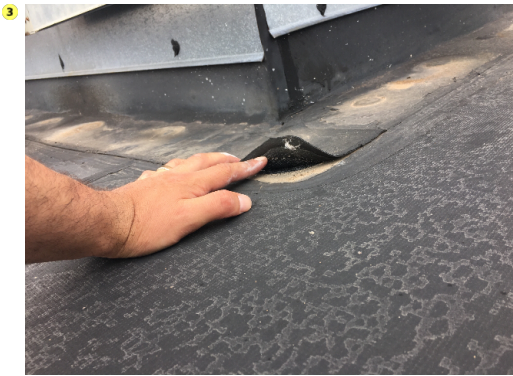
### General - Corner Flashing Open (Remedial)

Quantity: 12

Corner detail is open and needs to be sealed.

We will clean and prime the area and install patch to ensure water tightness.

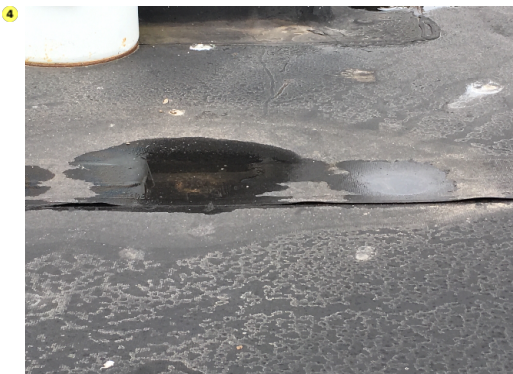
### General - Open Seams (Emergency)

Quantity: 100 LF

Open seams in the waterproofing membrane are typically caused by failing seam adhesives coupled with membrane shrinkage and stress on the seams.

The area surrounding the open seam must be cleaned. A new piece of waterproofing membrane would be installed and sealed per industry standards.

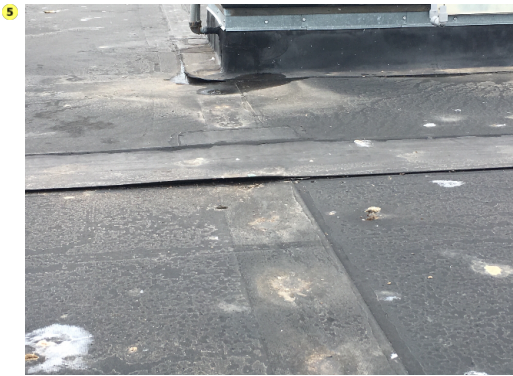
### General - Previous Repair Failure (Remedial)

Quantity: 50 LF

Existing repair failing due to age. Cover tape has lost adhesion on seam repair. HVAC curb flashing is failing.

We will remove the existing repair, clean and prime area and install new patch to ensure water tightness.
