## Management Report

DP Management  
Delta Plaza  
301 North Lincoln, Escanaba, MI

Prepared For  
**DP**  
MANAGEMENT, LLC

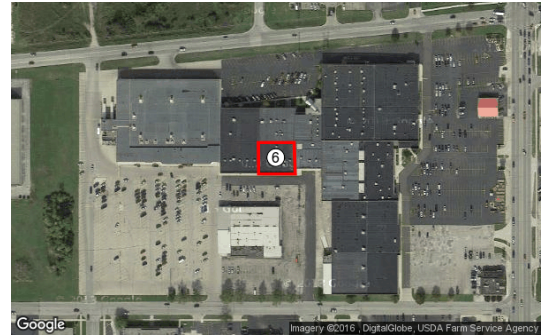
Membrane: F  
 Flashings: B  
 Sheet Metal: C

Overall: F

Emergency repairs should be made to prevent seam and patch failure's. Water intrusion is probable throughout section. Replacement should be budgeted for.

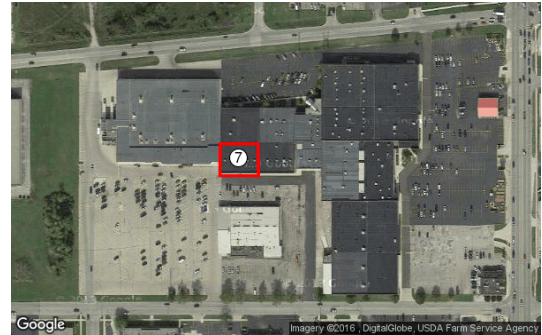
Membrane: F  
 Flashings: C  
 Sheet Metal: B

All seams are failing to different degrees. Some failures you can stick your hand in. All previous patch repairs are failing or failed. Corners of patches curled.

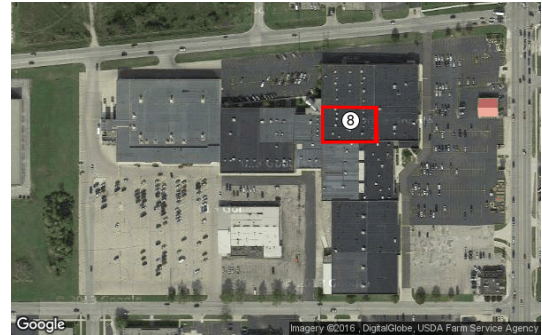
Membrane: F  
 Flashings: F  
 Sheet Metal: C

This roof section is failing throughout. Seams, flashings, and Penetration's are failed or failing. Roof replacement is needed.
